Moorepark Dairy Levy Research Update Teagasc Heavy Soils Programme Open Days

Moorepark Animal & Grassland Research and Innovation Centre

Con & Neilie Lehane, Ballinagree, Co. Cork - 6th May, 2015

Land Drainage Design Summary

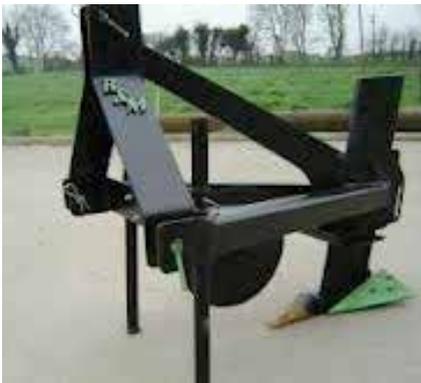
Figure 18: Single leg winged sub-soiler **Figure 19:** Collector drains

Sub-soiling was carried out with a single leg winged sub-soiler (Figure 18) to improve permeability of the upper layers and increase the level of infiltration of surface water into the soil profile and ultimately into the collector drains. The collector drains (Figure 19) were installed on July 4 – 6, 2013. Sub-soiling was carried out at a depth of 0.6 m and a spacing of 1.5 m on July 22, 2013 when good weather ensured dry soil conditions and allowed for the maximum level of soil disturbance. The depth of sub-soiling was set to ensure maximum fracturing and disturbance of the soil. The spacing was determined as the closest spacing allowable given the width of the tractor used for drawing the sub-soiler and the need to avoid tracking over the newly formed disruption channels.

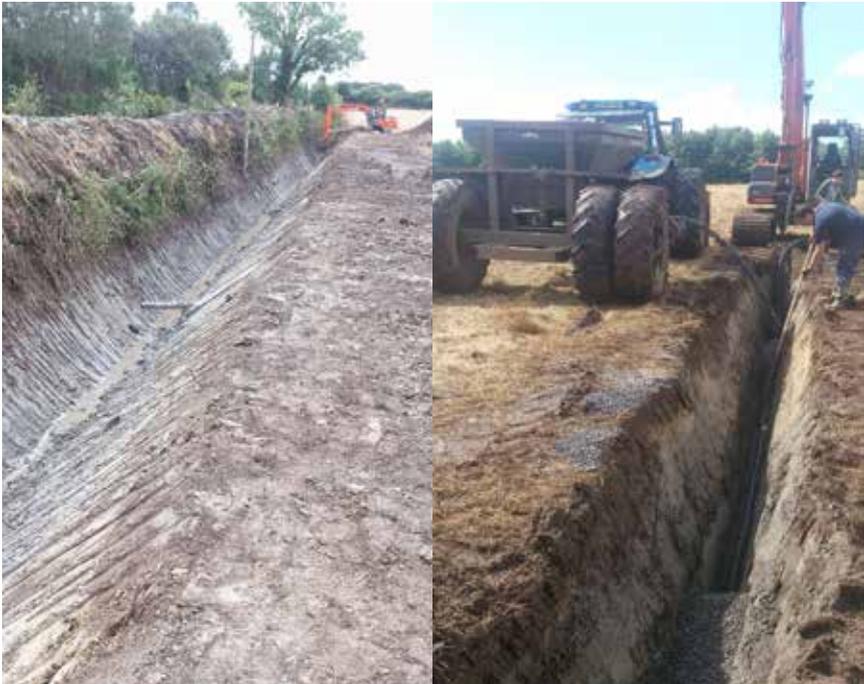
It was decided to install groundwater drains to a minimum depth of 1.7 m (*see map*) spanning the width of the site and running across the main field gradient. The placement of the drains did not follow any set pattern and was dictated by the field topography. Drains were positioned in natural depressions and along slope contours to ensure the natural flow of water was encouraged into drains. The existing open drain at the southern side of the site was cleaned and deepened to a depth of 2.0 m to act as an outfall for the new field drains. The existing culvert at the field outlet point was lowered to allow for this. This culvert was under a public road which had to be cut during the works and re-laid thereafter. Providing an outlet from the field was a major undertaking, an additional 250 m of open drain had to be excavated and the works required in the digging of this and removal of associated spoil added significantly to the overall cost. The existing open drain at the eastern side of the site was also deepened to 1.8 m, to intercept as much water (*coming from the adjacent areas*) as possible before it could enter the site. Drains were installed in two stages in order

to avoid difficulties related to subsidence and collapse of the field drain trench during installation. Initially a 1.0 m deep trench was excavated using a wide moulding bucket, after this a narrower tile drainage excavator bucket (as described earlier) was used to complete the drain to its final depth (1.7 m). Each drain was installed and backfilled immediately. Even using this strategy there was particular sections which collapsed and slowed the progress of installation. The groundwater drains consisted of an 80 mm corrugated perforated PVC pipe with a gravel aggregate envelope (10 - 40 mm grade) backfilled to within 1.2 m of the soil surface (to ensure maximum connection to the high permeability soil layer) and thereafter backfilled with soil.

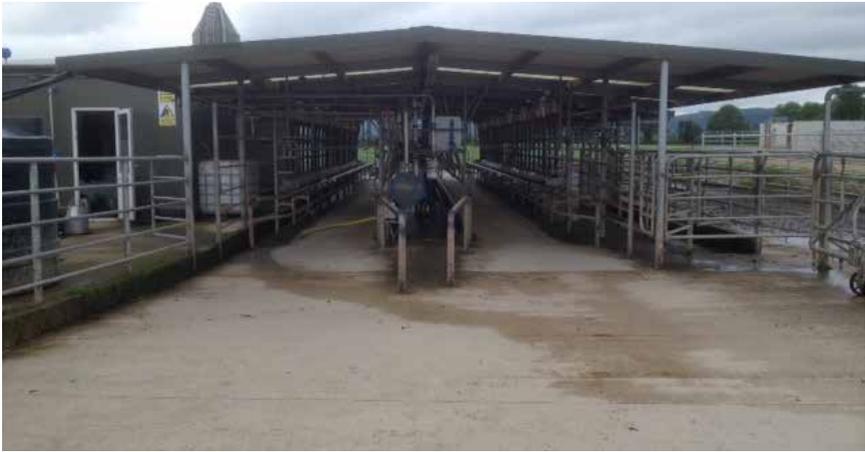
Figure 37: Cow Flow

- Good flow into a cattle crush is more important than the length of the cattle crush
- Avoid turning cows around corners into crushes
- Cows should be funnelled into crush at 30° angle (*straight on one side*)
- The basic instinct of animals is to return to where they came from. This should be taken into account when siting a crush.
- Traditional cattle crushes are good for restraining animals but not good for accessibility to animal, batch crushes provide greater accessibility
- Foot hoisting facility should be provided

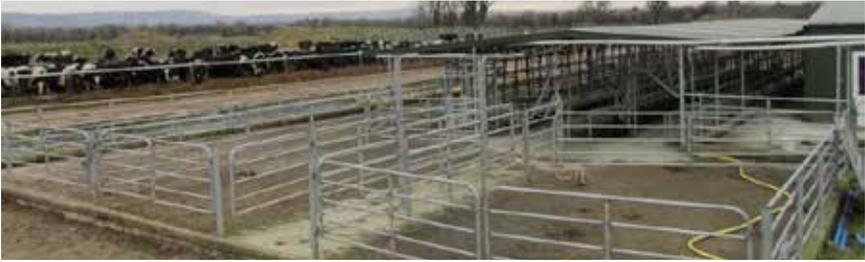
Figure 38: Drafting

- Milker should be able to draft without having to leave pit
- Farmers with good drafting facilities are inclined to AI for longer
- Drafting systems can be manual (*rope and pulley*) or automatic
- Front exit parlours make manual drafting easier
- Side exit parlours can also be drafted manually with a gate at exit.
- Holding pens for drafted animals should be large enough to hold 10% of herd
- Exit gates from parlour that can be operated from anywhere in pit are essential. Scissors gates are ideal in that they can be both opened and closed from anywhere in the pit.

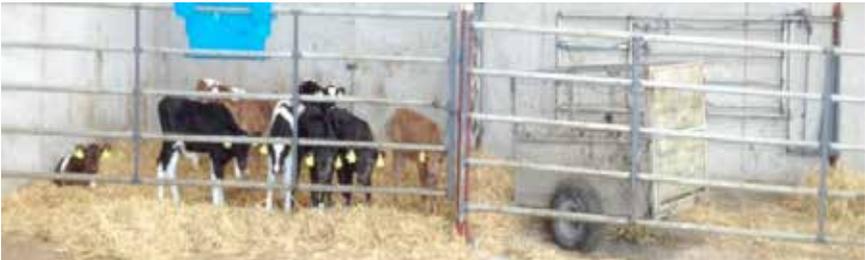
Figure 39: Calf Housing

- Simple multi-purpose design
- Well ventilated
- Easily cleaned
- Group pens
- Batch feeding

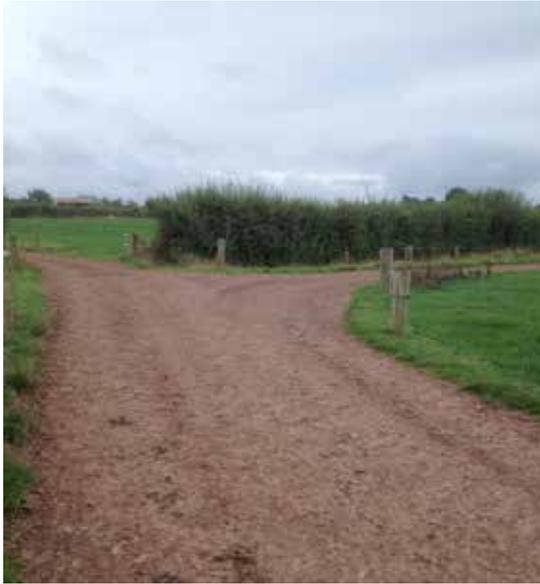
Figure 40: Grazing Infrastructure – roadways

Cows will make up to 600 return journeys from paddocks to the milking parlour each year. Road layout must allow for good cow flow and have a suitable surface for walking speed and hoof welfare. Road layout must allow access to all paddocks.
