# Moorepark Dairy Levy Research Update

## Teagasc Heavy Soils Programme – Lessons Learned

*A guide to the key findings of the Teagasc Heavy Soils Programme to-date*

May 2021

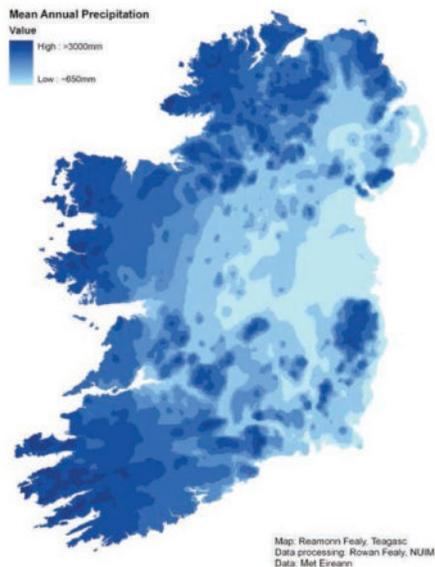
**Figure 2.** Mean annual precipitation in Ireland. Note increasing rainfall towards the West and with higher altitude. High rainfall areas on the East coast are related to the Wicklow and Mourne Mountains

The long-term annual rainfall values (met.ie) in the vicinity of HSP sites ranges from 982 mm (Rossmore, Tipperary) to 1,757 mm (Ballinagree, Cork), (Table 5). Typically, however, the Kishkeam, Co. Cork farm receives the highest rainfall level, since on-farm measurement began.

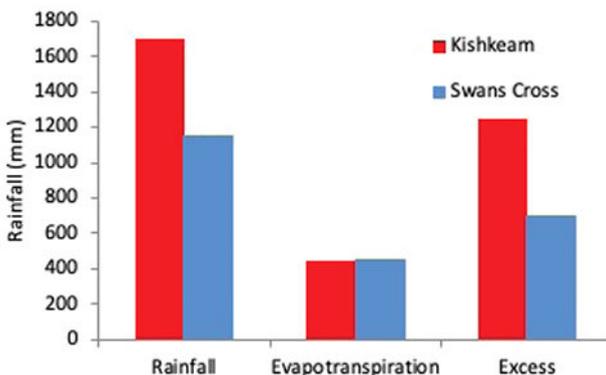
Figure 3. 2020 rainfall, evapotranspiration and excess at Kishkeam, Co. Cork and Swans Cross, Co. Monaghan farms

Another consideration is the “excess”, which is the amount of rainfall less the amount of evapotranspiration and is a measure of how much water is required to drain via overland flow or percolation through the soil. We can take the 2020 figures from the Kishkeam, Cork and Swans Cross, Monaghan farms (highest and lowest rainfall in that year) as an example. Total Rainfall was 1,697 mm and 1,151 mm respectively, while evapotranspiration was approximately 450 mm in both cases, leaving an excess in each case of 1,247 mm and 701 mm (Figure 3). Therefore, while rainfall is approx. 47% higher in Kishkeam, when evapotranspiration is accounted for, the amount of water to be drained in Kishkeam is actually 78% higher than at Swans Cross in 2020. This is important to bear in mind as evapotranspiration is reasonably uniform throughout the country, while rainfall is not. Every mm of rainfall above evapotranspiration equates to 10,000 Litres per Ha to drain. The drainage capacity of the soil and the local catchment will dictate what effect this will have on farm management.

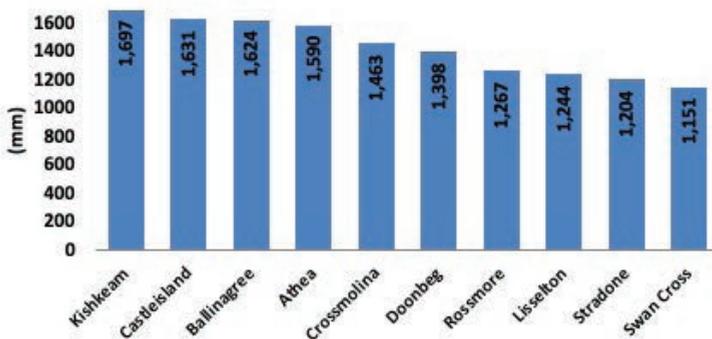
Figure 4. 2020 rainfall at all HSP farms

The total rainfall for each farm in 2020 is shown below (Figure 4).

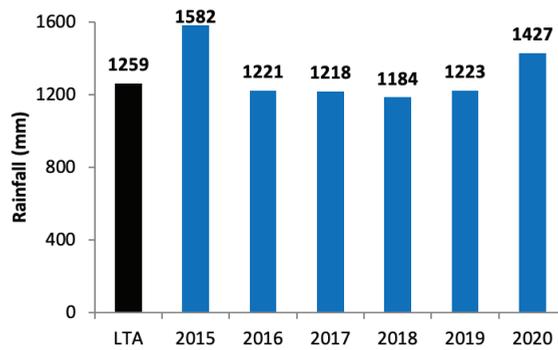
**Figure 5.** Long term average (LTA) annual rainfall across HSP sites compared with recent totals. Generally annual values do not vary hugely, with the exception of 2015. Seasonal variation gives a better indication of impact of rainfall on management

The wettest month in recent years was December 2015 which averaged 319 mm across farms, while April 2017 was recorded as the driest month (25.5 mm). We have seen a number of sustained wet and dry periods in the last number of years which have caused difficulties in terms of management, most notably in 2018 when persistent rain in Spring and early Summer give way to drought by mid-Summer. Generally rainfall doesn't tend to vary much from long-term average values in any given year but monthly variations can be significant during particularly wet and dry periods. As such annual average rainfall can mask the effects of seasonal variation (Figure 5).

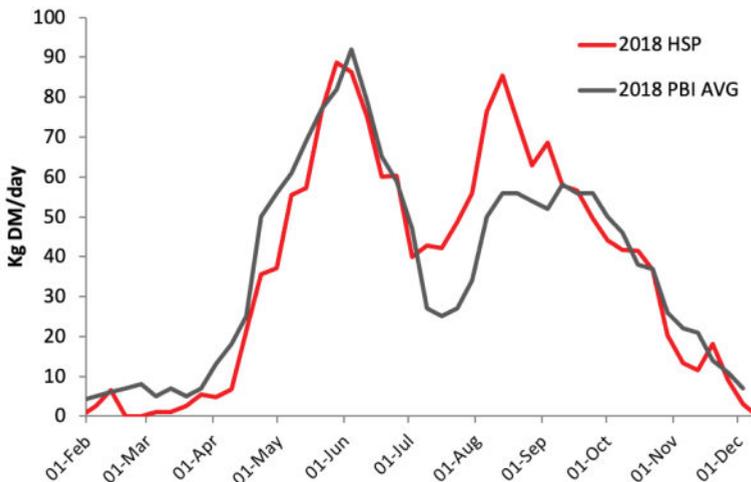
**Figure 6.** 2018 grass production on HSP farms compared with PBI (Pasturebase average)

The impact of extreme weather was highlighted in 2018. Soil moisture deficit (SMD) is the amount of rain needed to bring the soil moisture content back to field capacity, which is a scenario where soil moisture is neither excessive nor lacking. A negative SMD indicates saturation while positive values represent a deficit. A look at SMD in 2018 indicates the variability in soil moisture observed. On average soils remained saturated for the first 119 days of the year (to April 29<sup>th</sup>), within 37 days (by June 5<sup>th</sup>) a deficit of 30+ mm had been reached, beyond which growth is restricted, and SMD peaked at 80.3 mm by Mid-July with severely restricted growth throughout this period. While such extremes and particularly drought conditions are very rarely a concern on such soils, the restrictions are clearly observed in grass growth records (Figure 6).

In 2018, growth on the HSP farms was slow to start in the spring due to persistent rain and saturated soils. It then peaks in late May/Early June in line with PBI average performance. Growth began to be restricted at this time and a sharp drop is observed during the summer before rainfall in late July results in a second peak in growth. As would be expected for these soils, drought conditions did not affect growth as severely or for as long as on other farms.

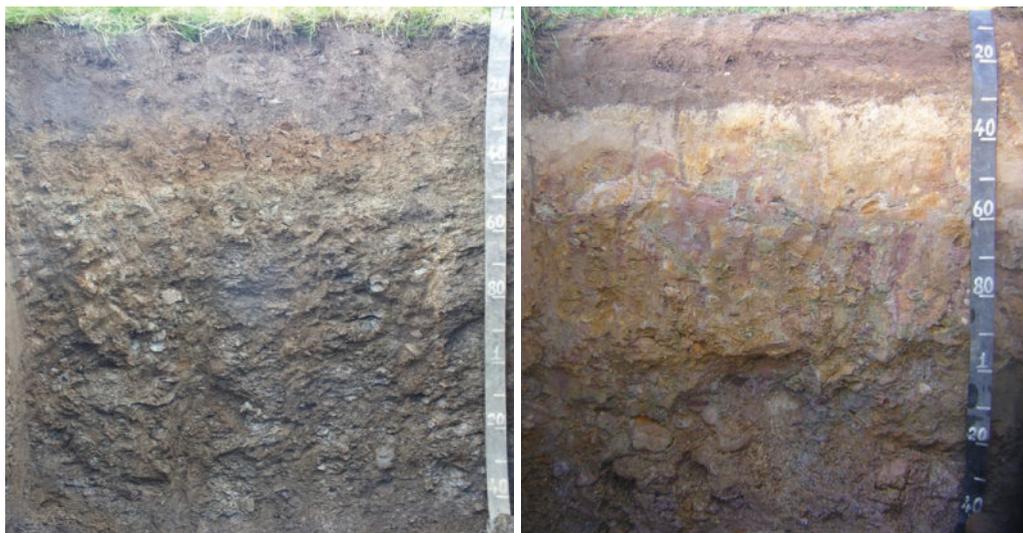
Stagnic Brown Earth: 14.0Ha in Stradone

Surface Water Gley: 12.4Ha in Rossmore

The natural variability of soils is apparent between different regions of the country, and indeed within farm boundaries. A campaign to classify, sample, measure and map soil type and characteristics at a paddock scale across the programme farms was undertaken as part of the Heavy Soils Programme. In order for the Programme to develop coherent and credible management techniques and strategies for all soil types and variations thereof, in-depth knowledge of the individual soils was required. The capture of high resolution and spatially explicit soil data enables an understanding of the agronomic and environmental aspects that need to be considered in the development of each farm. The deliverables from this exercise included: high resolution soil maps, detailed soil classifications, measurement and interpretation of soil hydrological and chemical characteristics and a bank of soil samples from each farm. The soil type, soil series and drainage class of the dominant soil in each paddock was outlined. Some example soil profiles are shown in Figure 7.

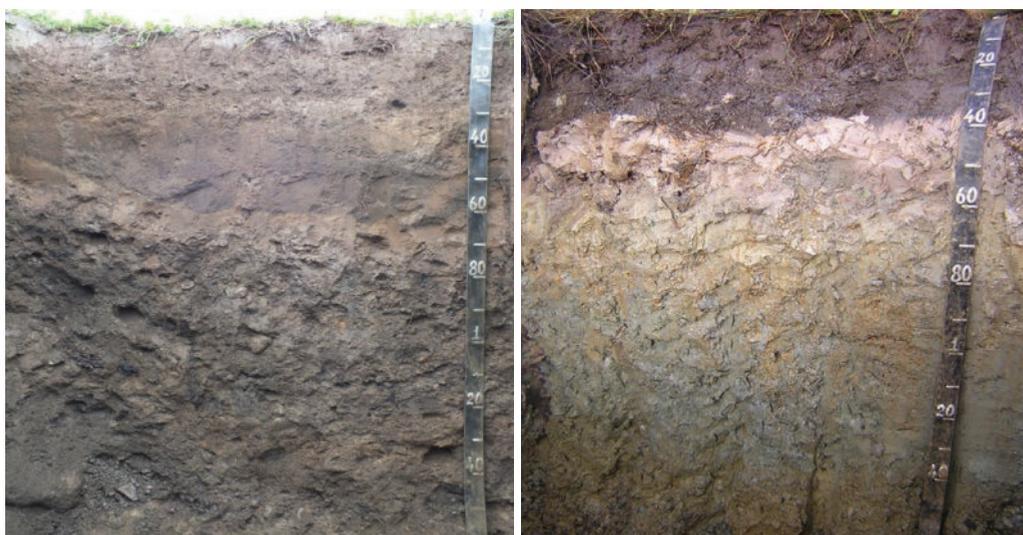
Gleyic Brown Earth: 12.4Ha in Crossmolina

Humic Alluvial Gley: 5.3 Ha in Kishkeam

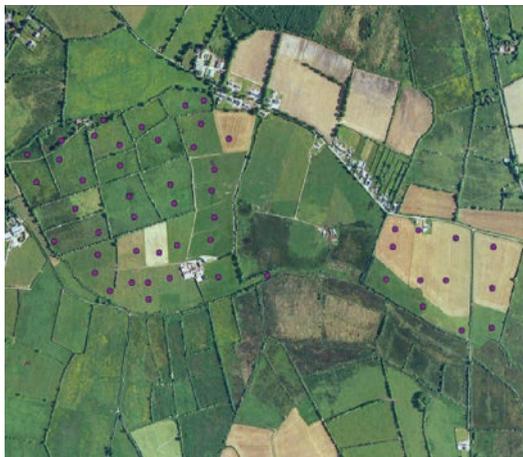
**Figure 8.** Extent of auger survey at Castleisland, Co. Kerry

Mapping of the location and extent of each soil type on a given farm was established through an auger and test pit survey. Initially an auger survey was carried out on each farm, involving an auger bore on average every hectare to investigate the soil physical features. Their resulting distribution was an even coverage across each farm (Figure 8). The Dutch auger was driven into the soil to a depth of 1 m. The soil features were described and recorded. Horizon type, depth, texture, colour, mottling, structure, roots and stones were recorded along with many more physical attributes detailed in the Irish Soil information system soil profile handbook. Soil type and drainage class were assigned.

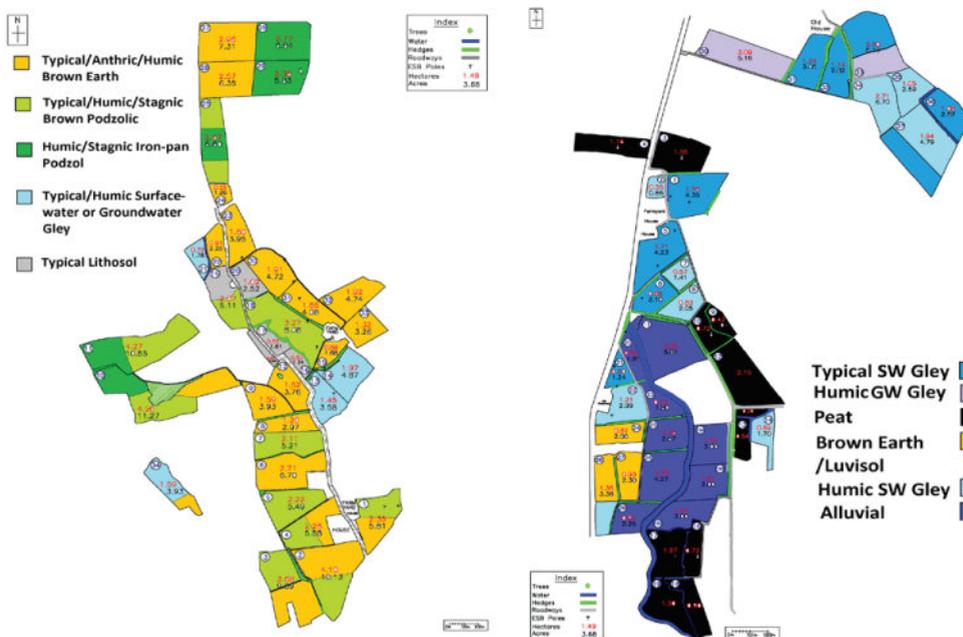
**Figure 9.** Soil classification maps for HSP sites at Ballinagree, Co. Cork and Doonbeg, Co. Clare

Thereafter a number (3-4) of representative soil profile pits were excavated using the auger survey as a guide to represent the dominant soils on each farm. These pits were 1-2 m in depth and allowed for detailed description of soils. In total 34 soil profiles were excavated across the 10 programme farms. This survey produced high resolution soils maps and detailed soil classifications of every soil subgroup on each farm (Figure 9).

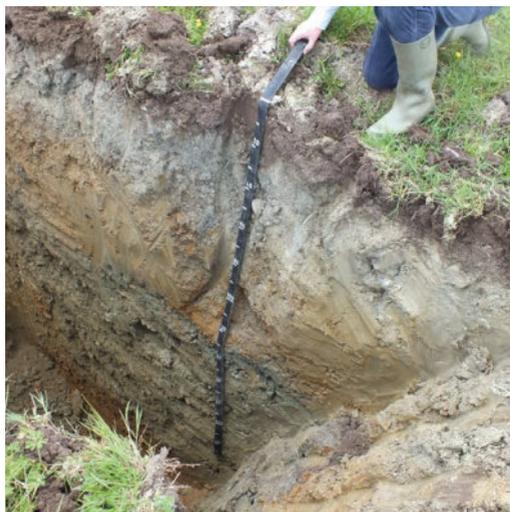
**Figure 10.** Test pit excavation

representative of the area as a whole; consider digging in wet and dry areas for comparison sake. Soil test pits are very dangerous and prone to collapse. You should not enter soil test pits but instead observe from a safe distance. Inspect different soil layers as they come up in the excavator bucket. As the test pits are dug, the faces of the pits are observed, soil type should be established and the rate and depth of water seepage into the test pit (if any) recorded. Visible cracking, areas of looser soil and rooting depth should be noted as these can convey important information regarding the drainage status of the different layers. The depth and type of the drain to be installed will depend on the interpretation of the characteristics revealed by the test pits.

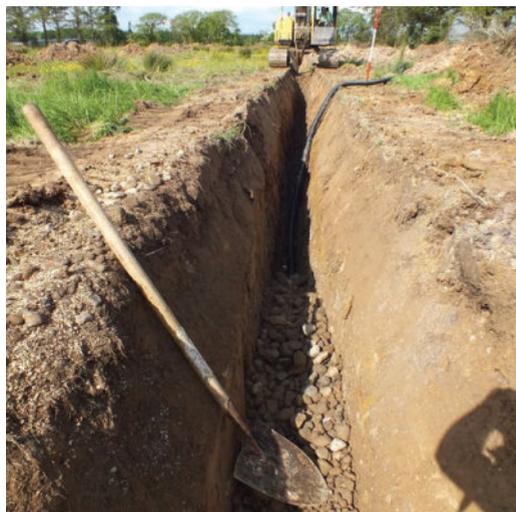
**Figure 11.** Drainage trench excavation

Clean aggregate, in the 10 – 40 mm grading band, should to be used to surround the drain pipe. The gravel should be filled to a minimum depth of 300 mm from the bottom of the drain to cover the pipe. The stone should provide connectivity to a layer of high permeability and should not be filled to the ground surface. The purpose of a drain pipe is to facilitate a path of least resistance for water flow. In long drain lengths (greater than 30m) a drain pipe is vital to allow a high a flow-rate as possible from the drain, stone backfill alone is unlikely to have sufficient flow capacity to cater for the water volume collected.

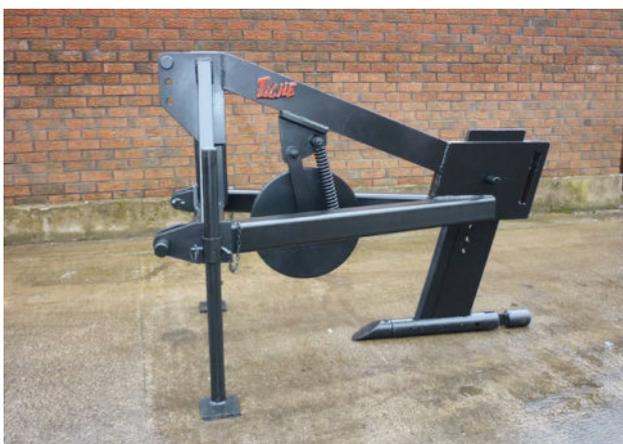
**Figure 12.** Mole plough showing cylindrical foot and expander

Mole drainage is suited to stone-free soils with a high clay content which form stable channels. Mole drains are formed with a mole plough comprised of a torpedo-like cylindrical foot attached to a narrow leg, followed by a slightly larger diameter cylindrical expander. The foot and trailing expander form the mole channel while the leg creates a narrow slot that extends from the soil surface to the mole channel depth. The mole plough creates both a zone of increased permeability adjacent to the mole leg (shallower depths) and a channel for water flow at moling depth. The effectiveness of mole drainage will depend on the extent soil cracking during installation. As such the ideal time for carrying out mole drainage is during dry summer conditions, to allow for maximum cracking in the upper soil layers and adequate traction to prevent wheel-spin on the surface.

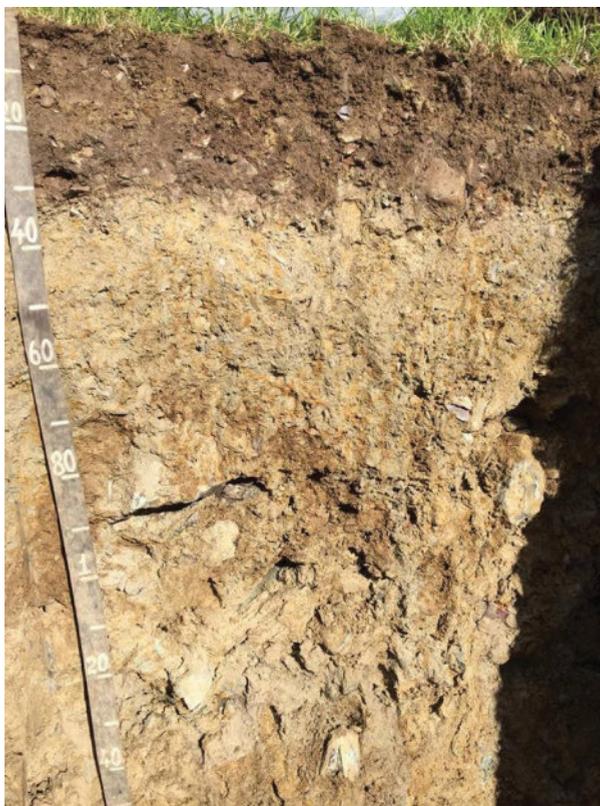
**Figure 15.** Typical soil profile at Ballinagree, Cork site

As a first step soil test pits were dug to examine the soil profile. The profile uncovered (pictured below) contained evidence of slow water infiltration (drainage) and movement. Strong seepage of groundwater into the pit was noted from approximately 1.5 m depth. Given the position of the site in the landscape (mid-slope on steep high ground) it was concluded that groundwater, moving downslope, was maintaining a shallow watertable and inhibiting surface water infiltration. Drainage on this site would have to remove this excess water to control the watertable depth and allow increased surface water infiltration. The design required is classed as a groundwater drainage system, comprising field drains located in the layer where groundwater can move (from approx. 1.5 m depth in this case). Soil test pits also uncovered a number of large stones and boulders (0.1 – 0.8 m approximately in size). Such stones would make excavation of field drains and removal of soil more problematical.

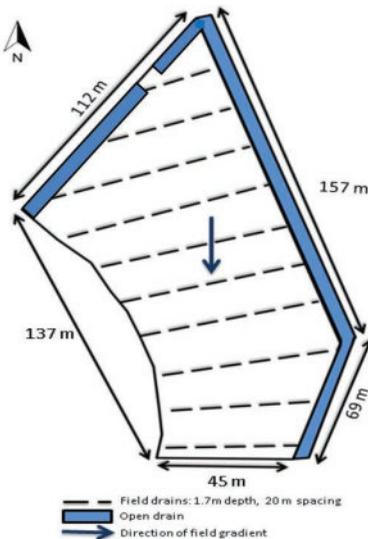
Figure 17. Drainage design map

It was decided to install groundwater drains to a minimum depth of 1.7 m and a 20 m spacing (see map) spanning the width of the site and running across the main field gradient. The existing open drain at the eastern side of the site was cleaned and deepened to a depth of 2 m to act as an outfall for the new field drains. The existing gullet at the field outlet point was lowered to allow for this. The existing open drain at the northern end of the site was also deepened to 1.7 m, to intercept as much groundwater and surface water (coming from the adjacent forestry) as possible before it could enter the site. Field drains were installed in two stages in order to avoid difficulties related to subsidence and collapse of the field drain trench during installation. Initially a 1.0 m deep trench was excavated using a wide moulding bucket, after this a narrower tile drainage excavator bucket (pictured below) was used to complete the drain to its final depth (1.7 m). Each drain was installed and backfilled immediately. The groundwater drains consisted of an 80 mm corrugated perforated PVC pipe with a gravel aggregate envelope (10 - 40 mm grade) backfilled to within 1.3 m of the soil surface (to ensure maximum connection to the high permeability soil layer) and thereafter backfilled with soil (and larger stones/boulders raised during drain excavation).

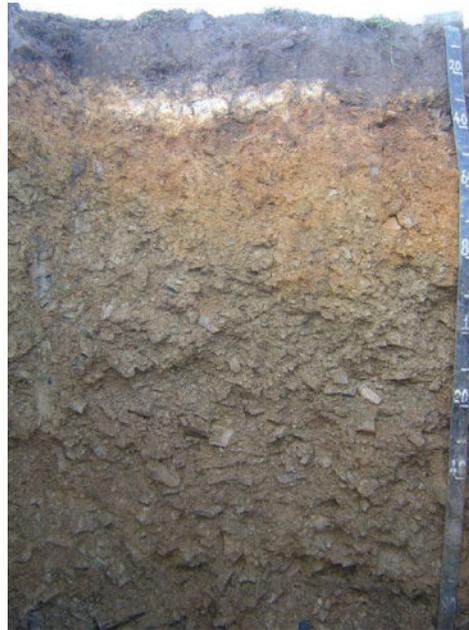
Figure 19. Typical soil profile at Kishkeam, Cork site

The information gathered from opening of on-site soil test pits indicated that the soil profile was consistently heavy and dense with abundant stones. In some areas there were lenses or zones of higher permeability with the potential for significant groundwater movement (at depths of 1.0-1.2 m). Drainage design in this case would have to provide an outlet for this groundwater while also improving the infiltration capacity of the heavy and dense subsoil commonly found.

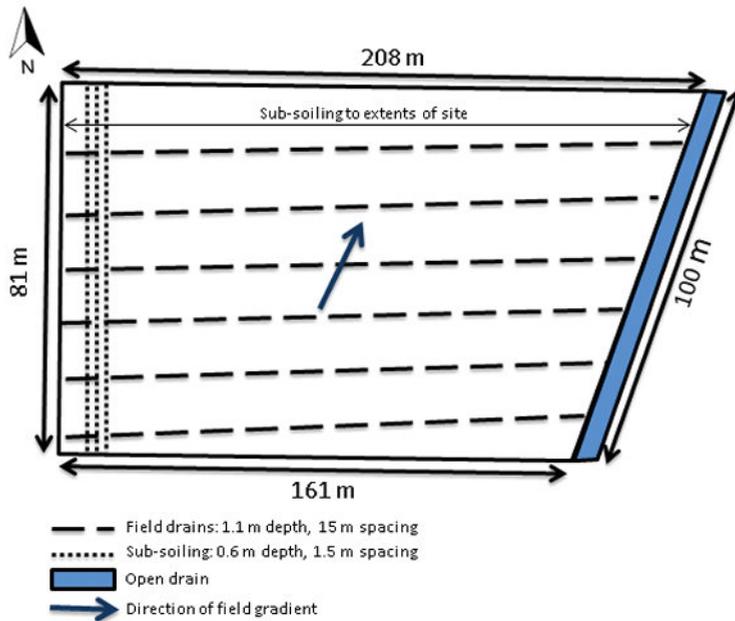
**Figure 21.** Drainage Design Map

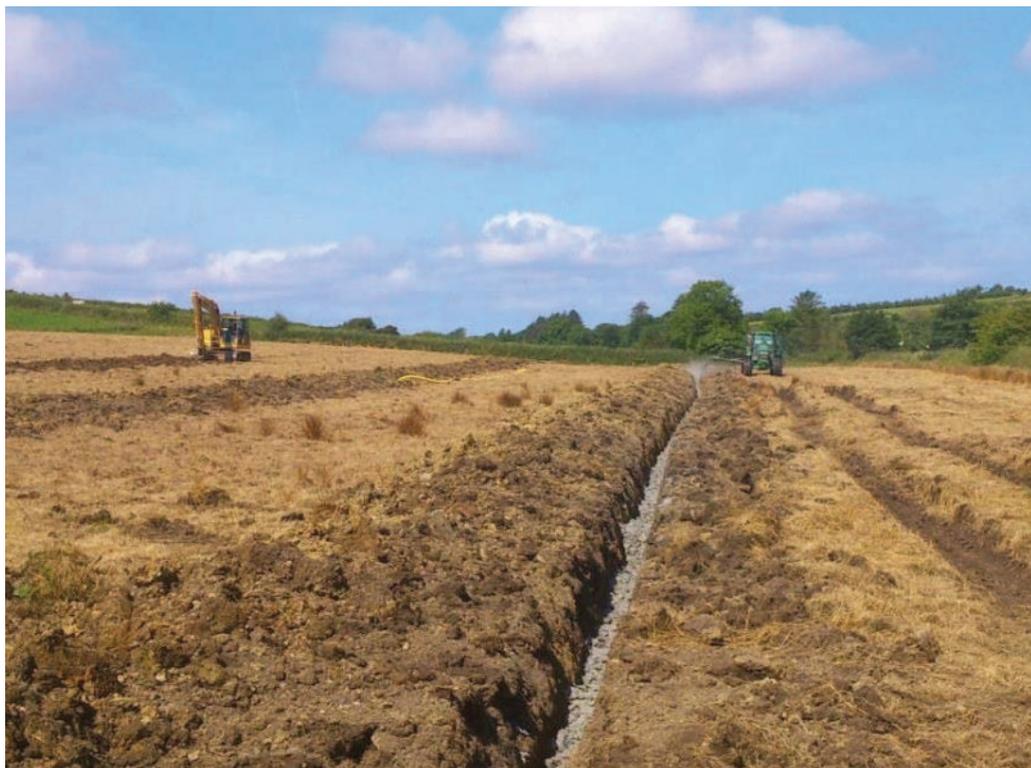
**Figure 22.** Drainage Work at Kishkeam, Co. Cork

Sub-soiling was carried out with a single leg winged sub-soiler (below) to improve permeability of the upper layers and increase the level of infiltration of surface water into the soil profile and ultimately into the collector drains. Sub-soiling was carried out at a depth of 0.6 m and a spacing of 1.5 m when good weather ensured dry soil conditions and allowed for the maximum level of soil disturbance. The depth of sub-soiling was set to ensure maximum fracturing and disturbance of the soil. The spacing was determined as the closest spacing allowable given the width of the tractor used for drawing the sub-soiler and the need to avoid tracking over the newly formed disruption channels.

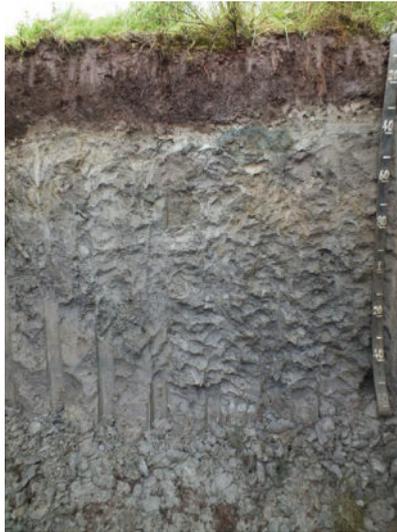
Figure 23. Typical soil profile at Crossmolina, Co. Mayo site

As a first step soil test pits were dug to examine the soil profile. The profile uncovered (pictured below) contained evidence of slow water infiltration (drainage) and movement. A thin topsoil was underlain by a uniform silt with some mottling (discolouration) becoming more permeable from 1.4 m depth. Strong seepage of groundwater into the pit was noted from approximately 1.4 m depth consistently across the site. The most appropriate drainage system for this site would be a groundwater drainage system which would remove excess groundwater and allow surface water to infiltrate through the profile. In this case the drains would be located in the layer where groundwater can move, at approximately 1.4 to 1.7 m.

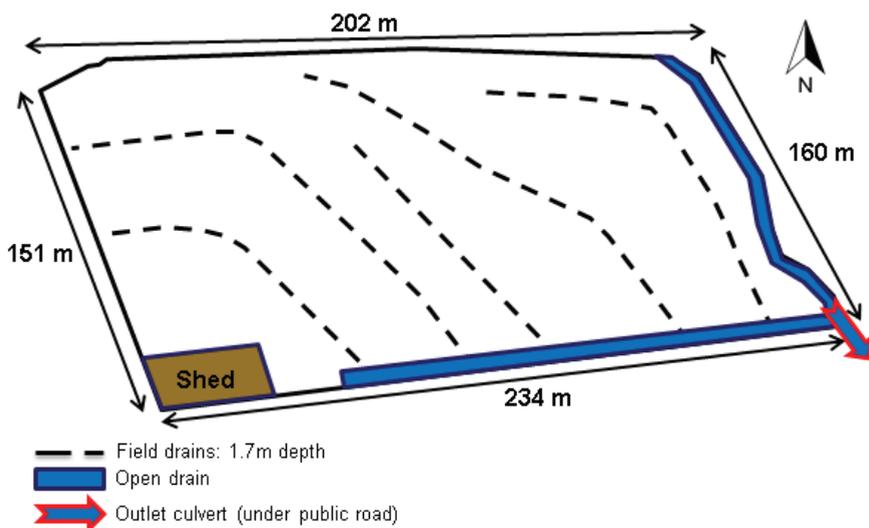
**Figure 25.** Drainage design map

The information gathered from the opening of on-site soil test pits indicated that the site was underlain by a consistent layer of highly permeable soil, first encountered at an approximate depth of 1.4 m below the surface. The high silt content as well as the presence of roots and structural cracks to substantial depths within the profile indicated that there was sufficient capacity for infiltration (drainage) of water through the profile to a groundwater drainage system. The purpose of the drainage system designed for the site was to target the highly permeable layer (from 1.4 m depth) and exploit the water carrying capacity it has.

It was decided to install groundwater drains to a minimum depth of 1.7 m (see map) spanning the width of the site and running across the main field gradient. The placement of the drains did not follow any set pattern and was dictated by the field topography. Drains were positioned in natural depressions and along slope contours to ensure the natural flow of water was encouraged into drains. The existing open drain at the southern side of the site was cleaned and deepened to a depth of 2.0 m to act as an outfall for the new field drains. The existing culvert at the field outlet point was lowered to allow for this. This culvert was under a public road which had to be cut during the works and re-laid thereafter. Providing an outlet from the field was a major undertaking, an additional 250 m of open drain had to be excavated and the works required in the digging of this and removal of associated spoil added significantly to the overall cost. The existing open drain at the northern end of the site was also deepened to 1.8 m, to intercept as much water (coming from the adjacent areas) as possible before it could enter the site. Drains were installed in two stages in order to avoid difficulties related to subsidence and collapse of the field drain trench during installation. Initially a 1.0 m deep trench was excavated using a wide moulding bucket, after this a narrower tile drainage excavator bucket (as described earlier) was used to complete the drain to its final depth (1.7 m). Each drain was installed and backfilled immediately. Even using this strategy there was particular sections which collapsed and slowed the progress of installation. The groundwater drains consisted of an 80 mm corrugated perforated PVC pipe with a gravel aggregate envelope (10 - 40 mm grade) backfilled to within 1.2 m of the soil surface (to ensure maximum connection to the high permeability soil layer) and thereafter backfilled with soil.

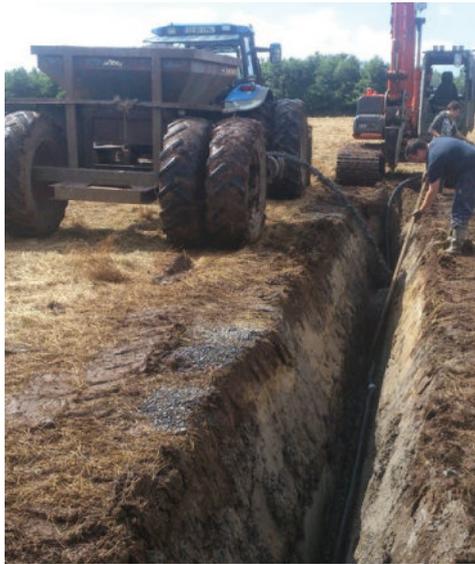
**Figure 26.** Drainage work at Crossmolina, Co. Mayo

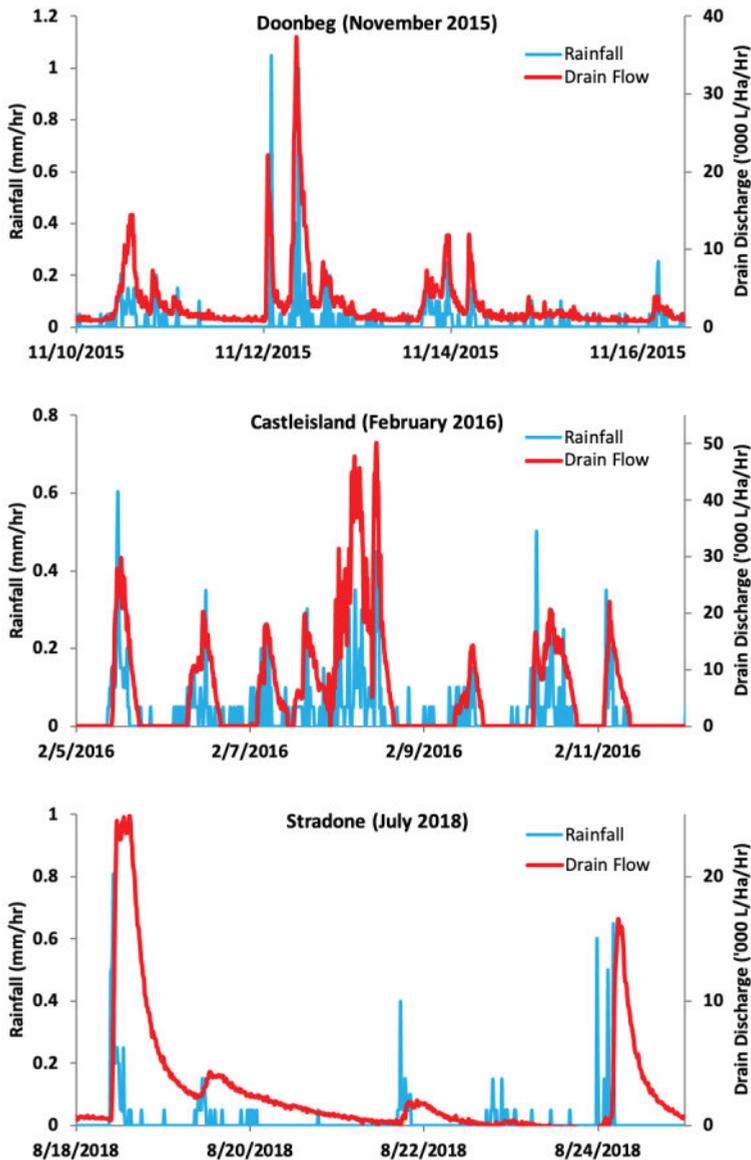
Figure 27. Drain discharge vs. rainfall at 3 drained sites

The response of each system to rainfall is quite clear. Examples are presented in Figure 27. In each drainage system, rainfall events show corresponding increases in drain discharge.

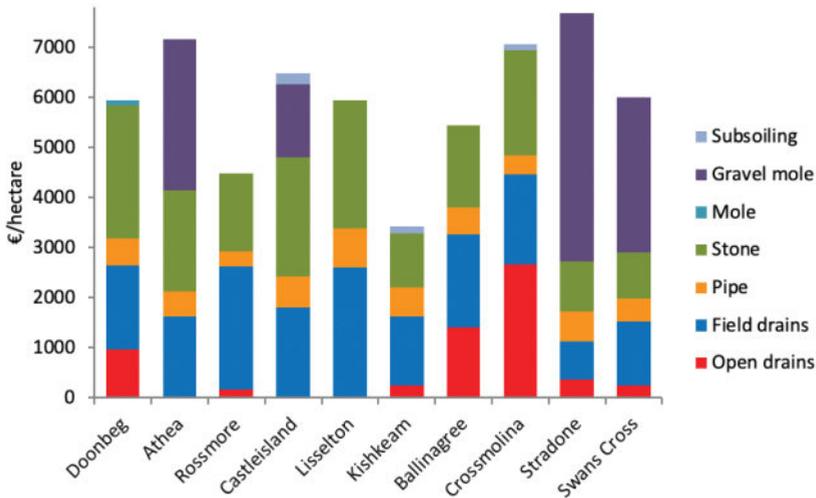
Figure 28. Land Drainage works costs at each HSP site

- The suitability of existing open drains as outfalls for the proposed field drains.
- The type of drainage system, particularly if a shallow drainage system was required.
- The intensity of field drainage required.
- The cost of and time taken by the contractor.
- The cost of materials, particularly stone aggregate.

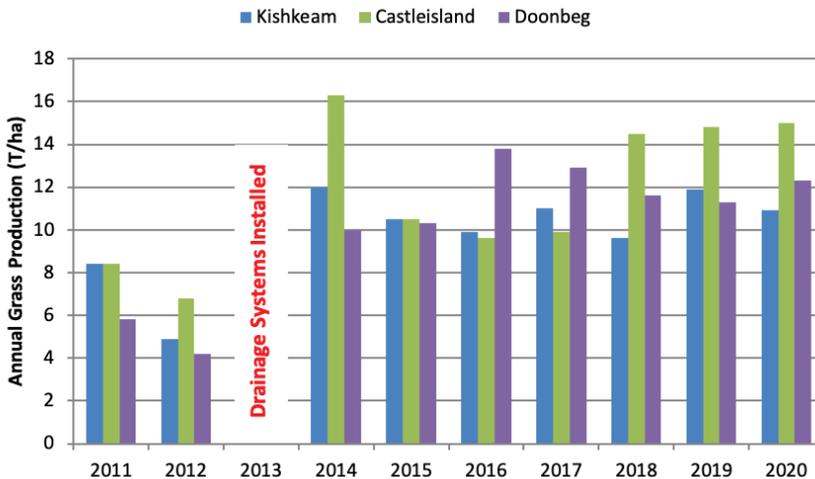
Figure 29. Grass growth at some drained sites before and after drainage works

All systems were shown to reduce the overall period of waterlogging and thereby improve the conditions for both the production and utilization of the grasslands they drain. **Drained sites increased grass production by between 4 and 7 T DM/Ha/year with a payback on capital invested of approximately 5-6 years.**

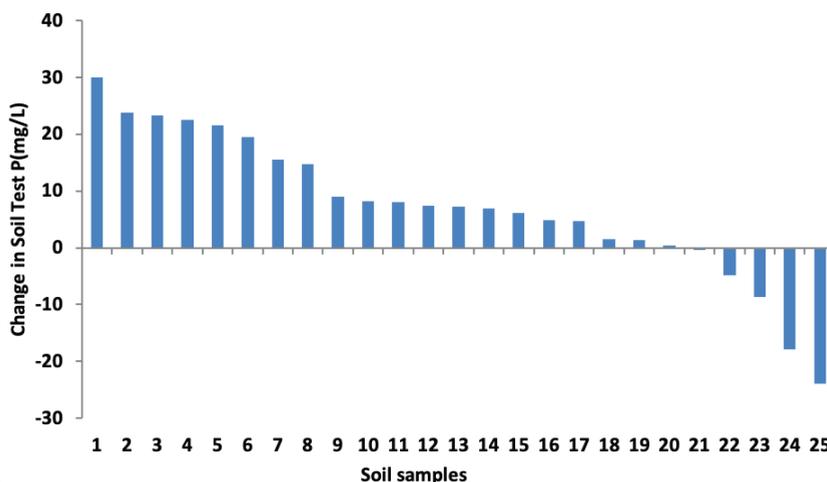
**Figure 31.** Change in soil test phosphorus (measured using the Mehlich 3 method and not the standard Morgan’s method so results are measured against a larger scale) following phosphorus application at 50 Kg/ha across 25 soil samples collected from heavy soils programme farms

A major issue with building soil fertility status on such soils is a disparity in responsiveness to applied nutrients or lime and high levels of nutrient fixing elements, principally iron and aluminium, at some sites which leave phosphorus unavailable for plant uptake. There are however large variations in response to phosphorus application between farms and soils within farms (Figure 31).

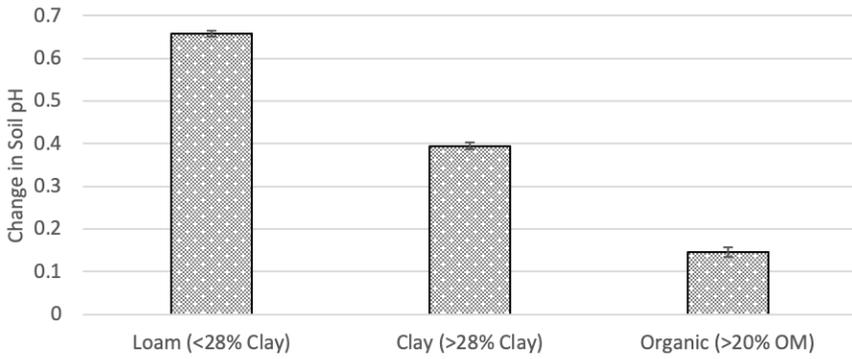
**Figure 32.** Change in soil pH in 3 soil groups following lime application at a rate of 5 T/ha

There remains a lot of room for improvement, which has led to detailed studies regarding individual response rates of soils through a series of intensive plot trials and incubated pot studies. This work has offered much insight into the responsiveness of individual soils across the Heavy Soils Programme farms. When grouped in 3 soil type categories; Loam (< 28% clay), Clay (>28% clay) and Organic (> 20% organic matter) there are clear differences in response to inputs. The “Loam” group shows a much stronger response to both lime (at a rate of 5 T/ha), (Figure 32) and phosphorus application (Figure 33) relative to the other categories.

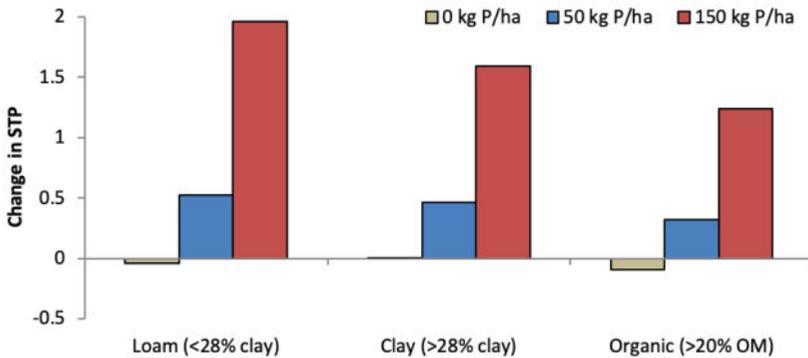
**Figure 33.** Change in soil test phosphorus in 3 soil groups at 0, 50 and 150 kg P/ha

Therefore, mineral soils (Loam and Clay) are shown to offer a much greater potential return for the phosphorus applied relative to organic soils with greater availability of plant available phosphorus and ultimately, greater production. Further analysis shows that phosphorus application to organic soils results in much higher levels of water soluble phosphorus relative to mineral soils. This is not plant available and is a measure of the risk of loss to surface and ground waters which is both an environmental and a financial loss as the nutrient applied is ultimately wasted.

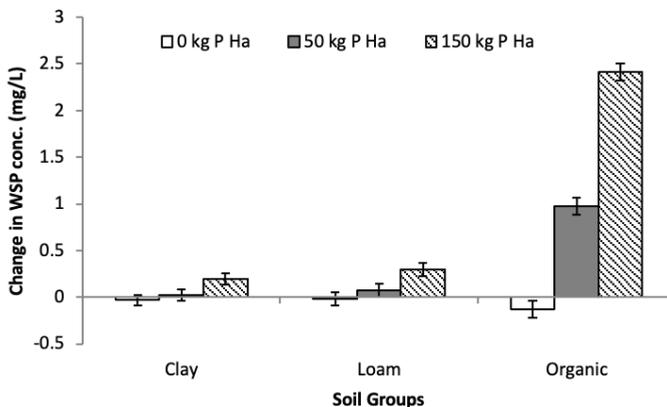
**Figure 34.** Change in water soluble phosphorus in 3 soil groups at 0, 50 and 150 kg P/ha

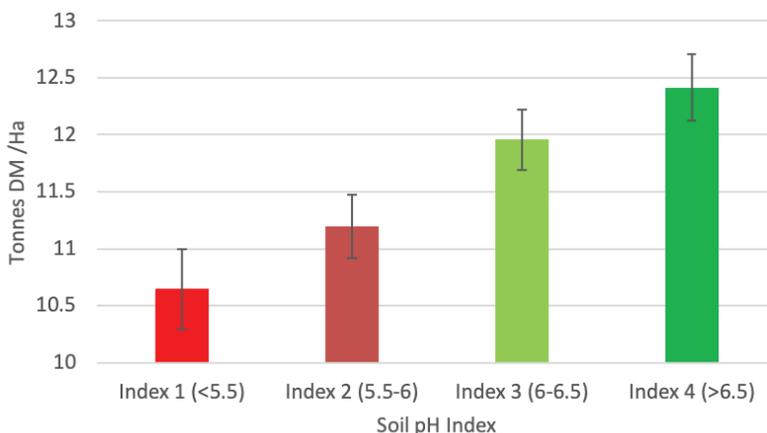
**Figure 35.** Influence of soil pH on grass production

The benefits of attaining optimum soil fertility have been shown. On HSP farms, those soils with a pH above 6.0 will produce an extra 1.3 Tonnes DM/ha relative to those soils with a pH below 6.0 (Figure 35). In terms of soil test phosphorus, Index 3 soils are shown to yield an additional 0.8 Tonnes DM/ha relative to Index 1 soils (Figure 36).

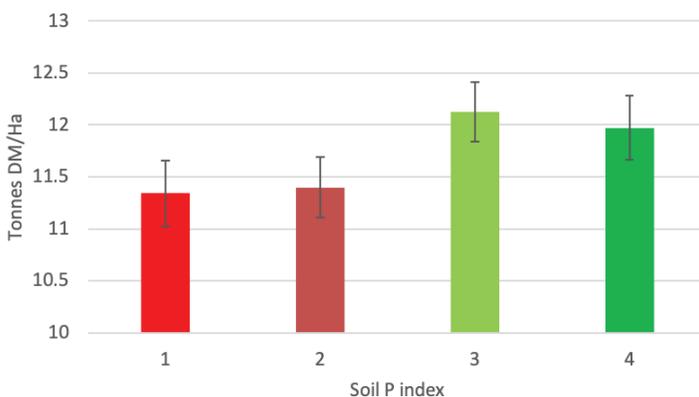
**Figure 36.** Influence of soil test phosphorus on grass production

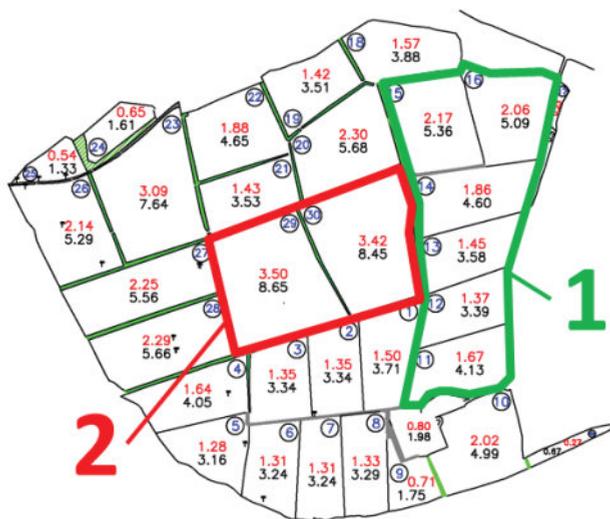
**Figure 37.** Focus areas 1 and 2 in which new grazing infrastructure was installed in 2018

It was decided that items 1 and 2, in the areas highlighted below, would be implemented in 2018 with other elements to follow thereafter.

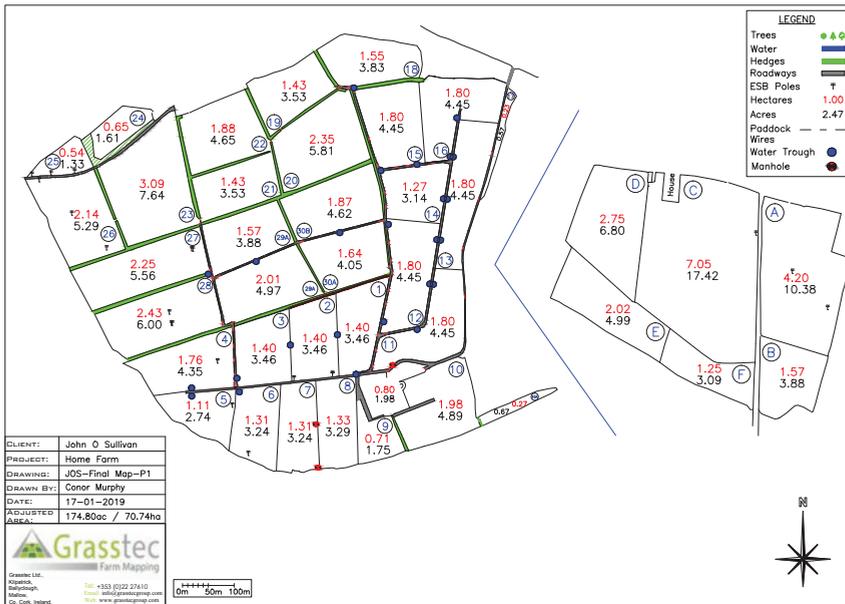
**Figure 38.** Newly completed farm roadways and spur roads installed in the areas highlighted above

Fortunately, the dry summer weather allowed these works to be completed in great conditions. The newly completed roadways are shown in the map below were completed in July/August of 2018.
