The Drainage of Impermeable Soils in High Rainfall Areas

Author(s): L. F. Galvin

Source: *Irish Journal of Agricultural Research*, Vol. 22, No. 2/3 (1983), pp. 161-187

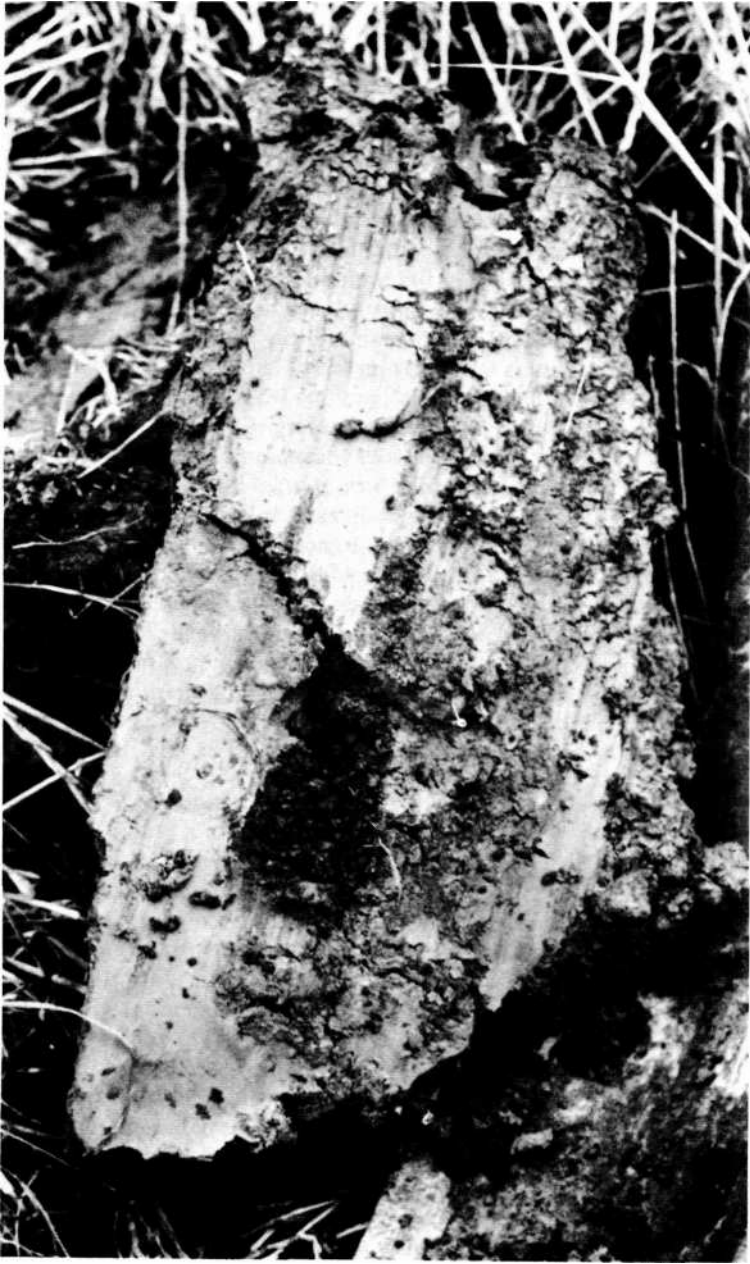
*Fig. 17: Rip track filled with topsoil*
